O-Ring Failure Analysis

For each O-ring application, there is a complex matrix of system parameters—pressure, temperature, friction, environmental exposure, and chemical exposure. All of these parameters must be considered together when designing the O-ring gland and selecting the O-ring size and elastomer in order to ensure long-term seal reliability. This section describes the most common failure modes seen in O-ring applications. It then suggests what design factors may contribute to each failure mode and what corrective actions can be taken to eliminate the failures.

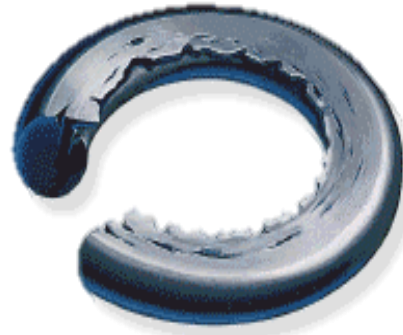
Extrusion or Nibbling

Description: The seal develops ragged edges, generally on the low pressure side, which appear tattered. This condition is more common with high pressure systems.

- Excessive clearances
- Excessive System Pressure
- Irregular clearance gaps due to eccentricity
- Sharp groove edges
- Low-modulus/ low-hardness elastomer
- Softening of elastomer due to fluid incompatibility
- Excessive gland fill
- Expansion of cylinder wall due to pressure

- Decrease clearances
- Decrease system pressure if possible
- Use back-up ring
Increase rigidity and concentricity of metal components
- Break edges of groove to minimum of .004" (0.10mm)
- Use higher modulus/higher-hardness elastomer
- Use more chemical compatible elastomer
- Increase groove width or change O-ring size
- Stiffen cylinder wall to limit expansion

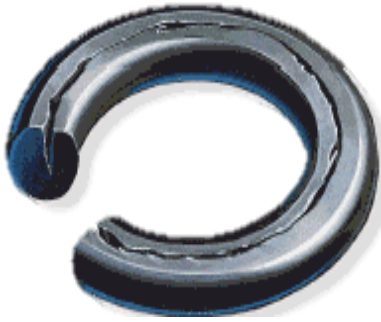
Over-Compression

Description: The seal exhibits parallel flat surfaces corresponding to the sealing surfaces. May also develop circumferential splits within the flattened surfaces.

- Excessive compression squeeze
- Elastomer with poor compression set properties
- Elastomer with inadequate heat resistance
- Elastomer that swells excessively in system fluid
- Improperly cured part used

- Use smaller o-ring or adjust gland dimensions
- Use material with better compression set resistance
- Use more heat resistant elastomer
- Use more chemically resistant elastomer
- Check cure state of parts prior to installation

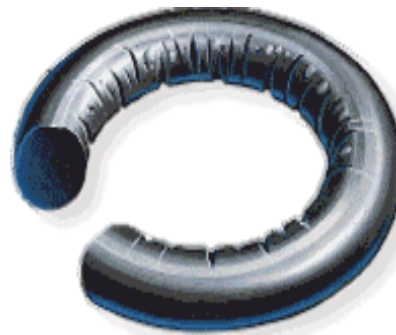
Heat Hardening / Thermal Degradation

Description: The seal may exhibit radial cracking on the highest temperature surfaces, often accompanied by the flattening of the seal characteristic of over-compression. Certain elastomers may exhibit signs of softening, such as a shiny surface.

- Thermal properties of elastomer
- Excessive temperatures, temperature excursions or temperature cycling

- Select more heat-resistant elastomer
- Select elastomer containing antioxidants
- Consider possibility of cooling sealing surfaces
- Increase thermal mass to dampen temperature cycling or excursions
- Change the position of the gland away from heat source

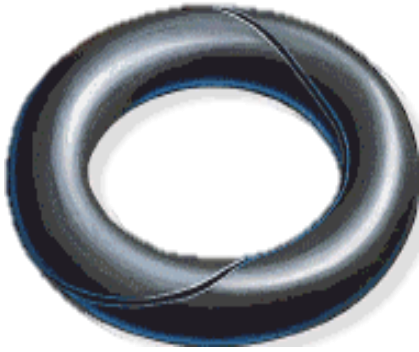
Spiral Failure

Description: The seal surface exhibits a series of deep, spiral, 45°-angle cuts. This failure is often seen with long-stroke, hydraulic piston seals.

- Eccentric components
- Wide clearances in combination with side loads
- Uneven surface finishes
- Inadequate lubrication
- Elastomer is too soft
- Stroke speed too slow-dynamic reciprocating

- Increase rigidity and concentricity of metal components
- Decrease clearances
- Machine metal surfaces to 10 to 20µinch surface finish
- Specify an external lubricant or use an internally lubricated material
- Use a higher durometer material
- Increase stroke speed or use D-ring instead of O-ring

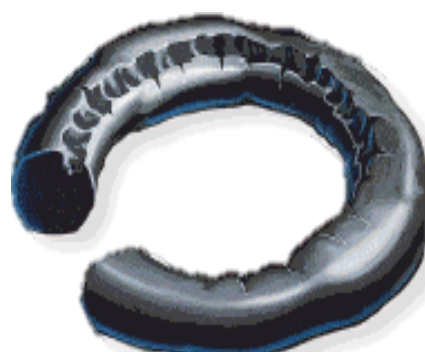
Chemical Degradation

Description: The seal may exhibit many signs of degradation including blisters, cracks, voids or discoloration. However, in some cases the degradation is only detectable by measurement of physical properties.

- Incompatibility with chemical environment

- Use more chemically resistant elastomer
- Use PTFE encapsulated O-rings
- Decrease temperature that O-ring sees, as higher temperatures accelerate chemical degradation.

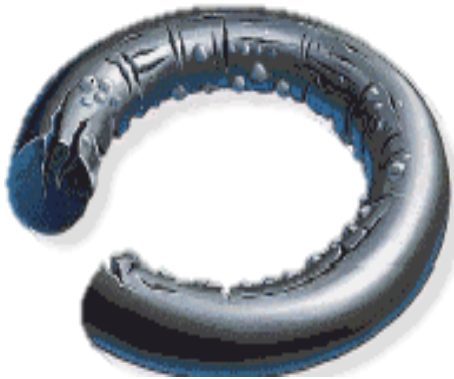
Explosive Decompression

Description: Explosive decompression results when high-pressure gases are absorbed by the seal, and then, as the pressure is rapidly dropped, the expanding gasses are trapped in the micropores of the elastomer, causing surface blisters and ruptures as they escape. The effected seals will exhibit random short splits or ruptures deep into the seal cross-section. When first removed the surface may also be covered with small blisters.

- Rapid pressure drop from high pressure
- Low-modulus/low- hardness ealstomer

- Slow the release of system pressure
- Specifity a higher-modulus/higher-hardness material
- Specify a decompression-resistant material

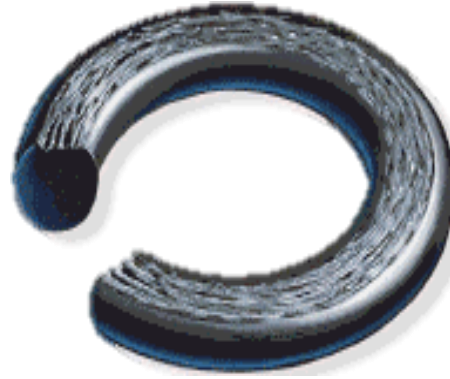
Description: Abrasion occurs only with dynamic seals-seals involved with a rotary, oscillating or reciprocating motion. The seal or parts of the seal exhibit a single flat surface parallel to the direction of motion. Loose particles and scrapes may be found on the seal surface.

- Rough sealing surfaces
- Sealing surfaces too smooth to allow for adequate lubriation
- Process environment containing obrasie particles

- Use recommended gland surface finishes
- Eliminate abrasive components or protect seal from exposure to them

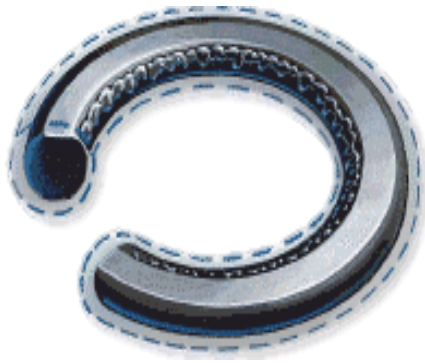
Plasticizer Extraction

Description: Seen primarily in fuel systems, plasticizer extraction is characterized by a loss of volume or weight of the seal. It is often difficult to detect with only a visual inspection.

- Heavy use of plasticizers to achieve
- Exposure to organic solvents compatible with plasticizers used

- Switch to elastomer with low-temperature properties to plasticizers aren't needed
- Change plasticizers used to ones less compatible with process fluids

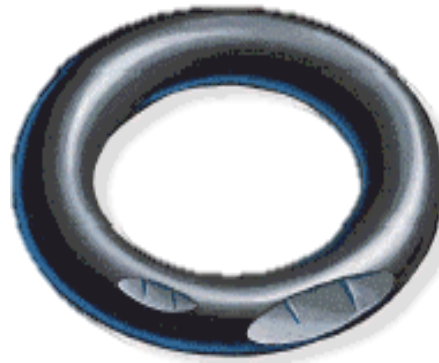
Installation Damage

Description: The seal or parts of the seal may exhibit small cuts, nicks or gashes.

- Sharp surfaces on glands or components
- Inadequate lead-in chamfer
- O-ring too large for gland
- Low-modulus/Low-hardness elastomer

- Break all sharp metal edges and cover threads with tubes or tape for installation
- Provide 15° lead-in chamfer of adequate length so O-ring sees only chamfer
- Review gland and o-ring design per recommended design standards
- Specify a higher-modulus/higher-hardness material

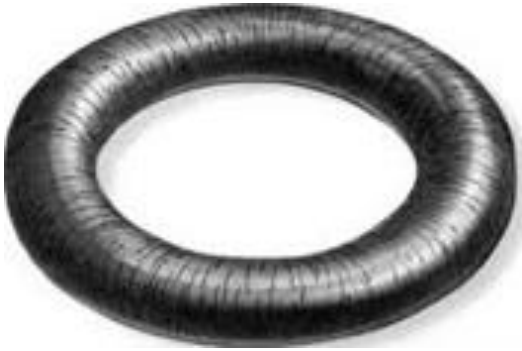
Weather or Ozone Cracking

Description: Occurring in seals exposed to Ozone, UV radiation or other air pollutants, weather or ozone cracking is characterized by small surface cracks perpendicular to the direction of stress.

- Exposure to ozone, UV radiation or other air pollutants
- Excessive seal stretch (>5% ID stretch)

- Select more ozone-and UV-resistant elastomer
- Apply anti-ozonant or wax coating to seal
- Modify the design to avoid the damaging exposure
- Modify design to reduce stretch to less than 5%
